DOE/NV--1218

Post-Closure Inspection and
Monitoring Report for Corrective
Action Unit 110: Area 3 WMD
U-3ax/bl Crater,
Nevada Test Site, Nevada

For the Period July 2006 - June 2007

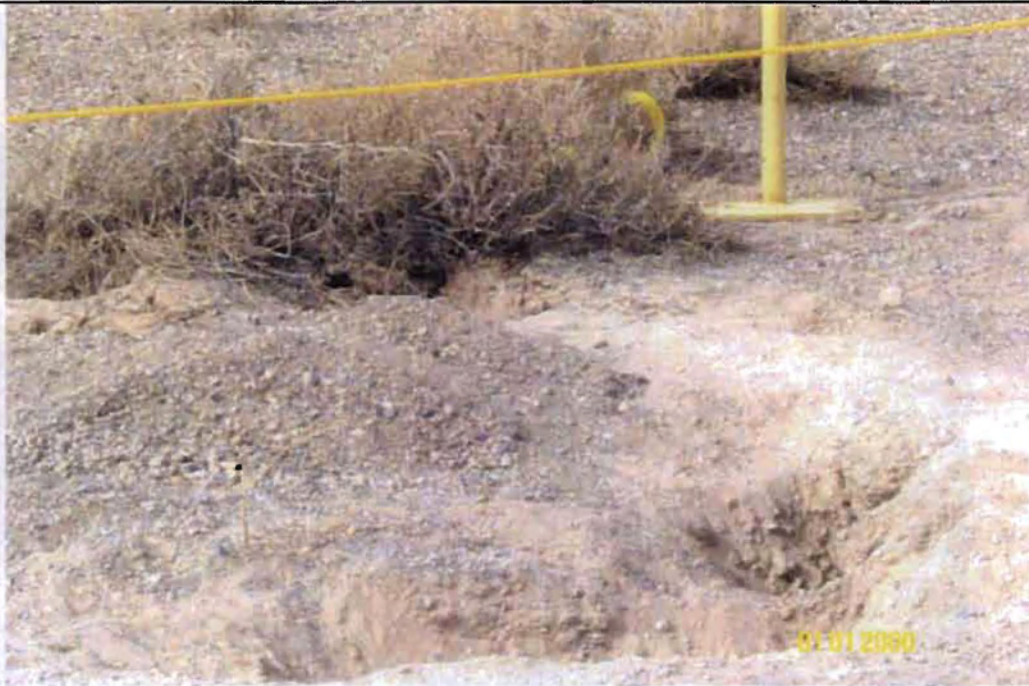
11/01/2006

During the September 19, 2006, inspection, one area of settling on the southeast portion of the cover exceeded the settling compliance criterion. The area along the east side of the cover had been repaired on several previous occasions. The area was repaired over the period of December 12 - 13, 2006. A portable, gas-powered tamper was used to compact the cracks in the cover. The area was backfilled with clean, native soil using wheelbarrows and shovels, and then compacted using the tamper. Field notes for this repair are included in Appendix A.

9. View of subsidence on the southeast edge of the Area 3 WMD U-3ax/bl cover.

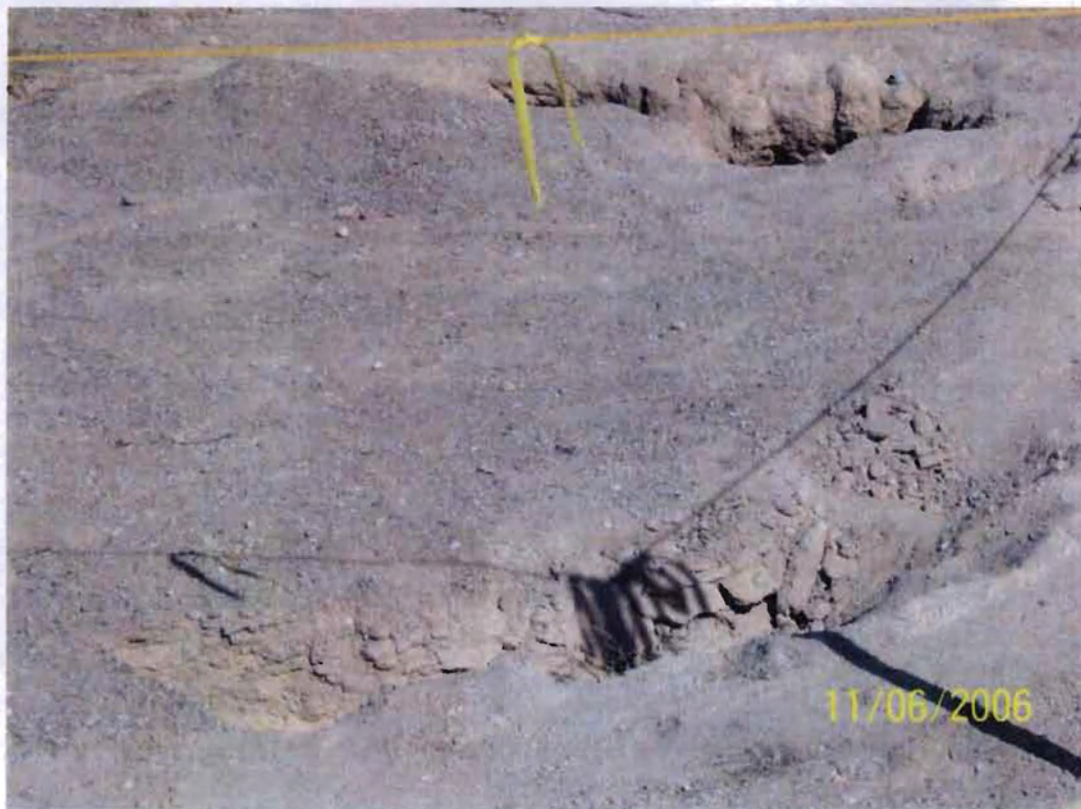
11/06/2006

10. View of cracking on the southeast edge of the Area 3 WMD U-3ax/bl cover.

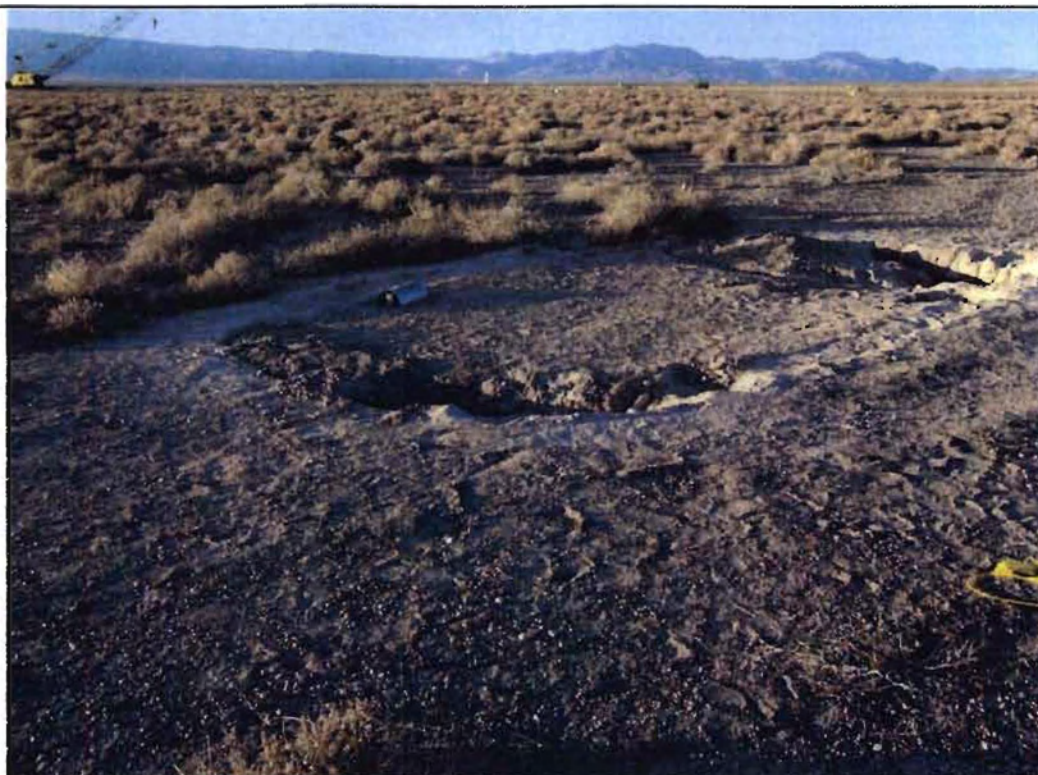
11/08/2006

11. View of subsidence on the southeast edge of the Area 3 WMD U-3ax/bl cover.

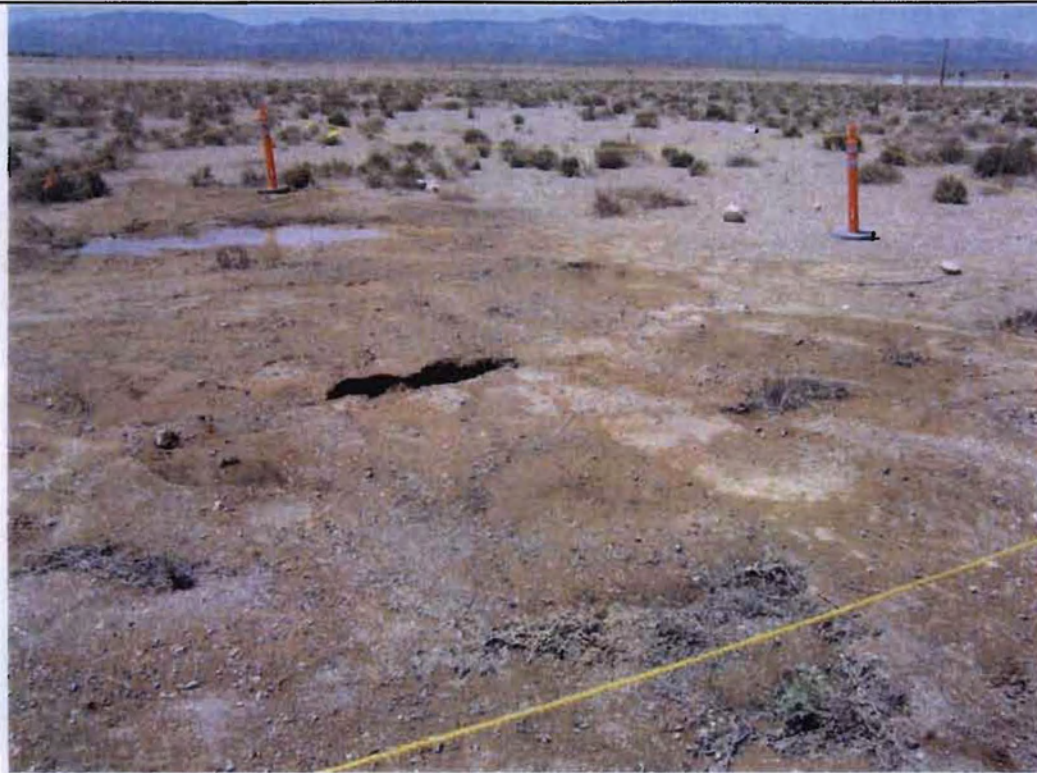
05/14/2007

- Settling imperfections were discovered that exceeded the compliance criterion, which extended 3 to 4 ft on the northeast edge of the cover.
- Extensive animal burrowing was noted across the area of the cover.
- The condition of UR warning signs, fencing, TDR stations, SMs, and cover vegetation was good.

During the March 29, 2007, site inspection, an area of settling on the northeast edge of the cover exceeded the settling compliance criterion. The area along the east side of the cover had been repaired on several previous occasions. The area was repaired over the period of May 10 - 14, 2007. A portable, gas-powered tamper was used to compact the cracks in the cover. The area was backfilled with clean, native soil using wheelbarrows and shovels, and then compacted using the tamper. Field notes for this repair are included in Appendix A.

29. View of subsidence on the northeast edge of the Area 3 WMD U-3ax/bl cover.

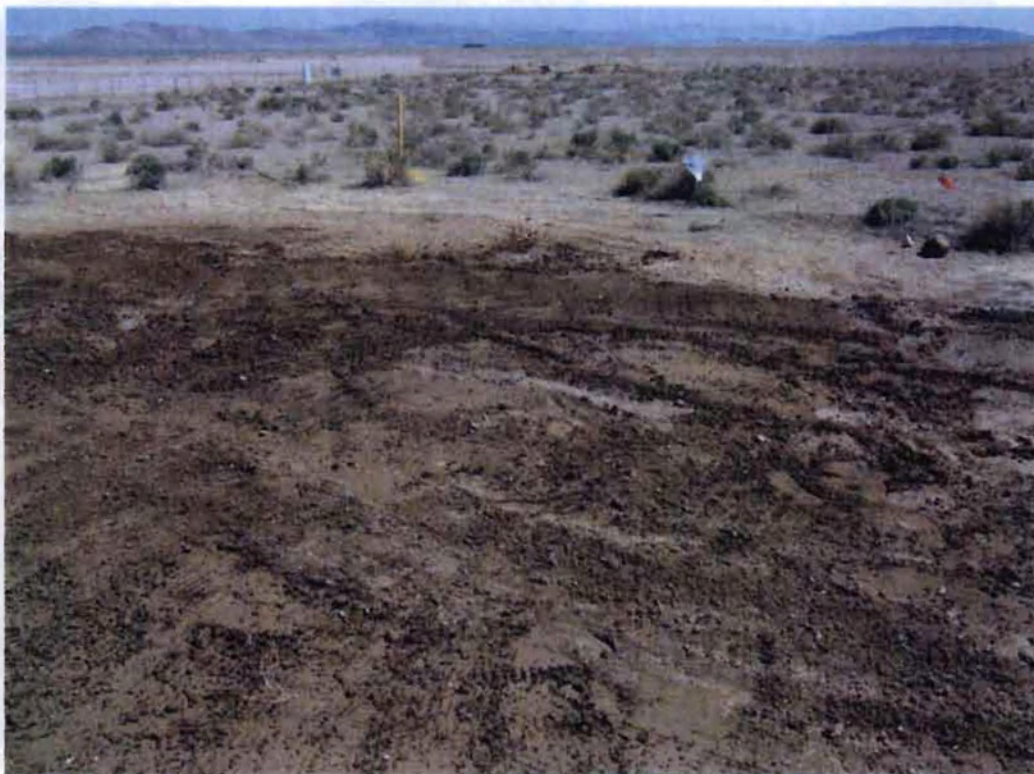
05/14/2007

30. View of repairs of the northeast edge of the Area 3 WMD U-3ax/bl cover.

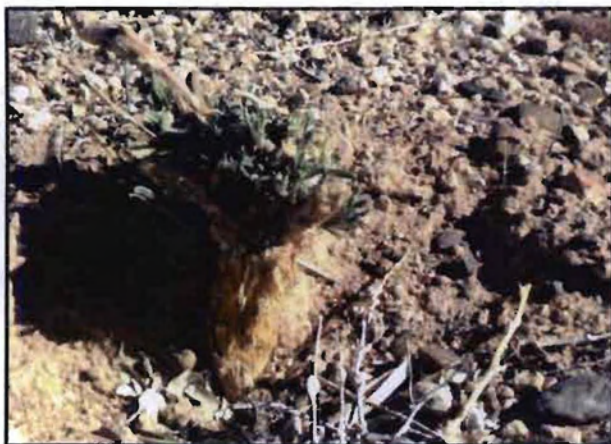
conditions the last couple years have left these two groups of animals without sufficient food. It was evident during the vegetation sampling session this year that many plants are being grazed to a point where they may not recover. The most common plant experiencing heavy utilization is winterfat (Figure 3). It is more palatable than shadscale or Nevada ephedra and is preferred by browsing animals. Shadscale also showed signs of heavy browsing (Figure 4). This is quite uncommon because this species is not commonly browsed. The spiny nature of the plant and the high salt content of the leaves make this plant a less desirable plant for browsers. In many instances not only has the above ground biomass been browsed, but animals have burrowed into

Figure 3. Severe browsing of foliage and roots of winterfat.

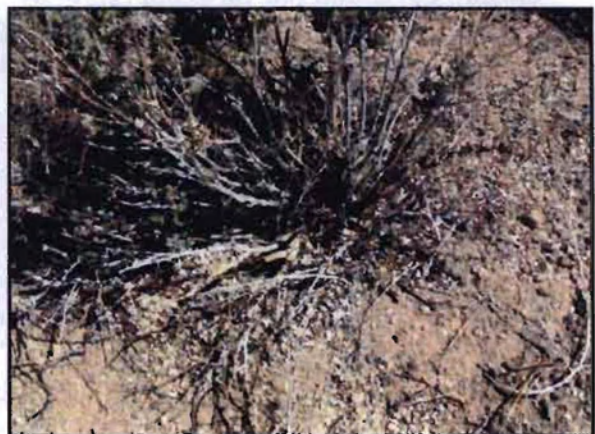
Figure 4. Severe browsing of stems of shadscale.

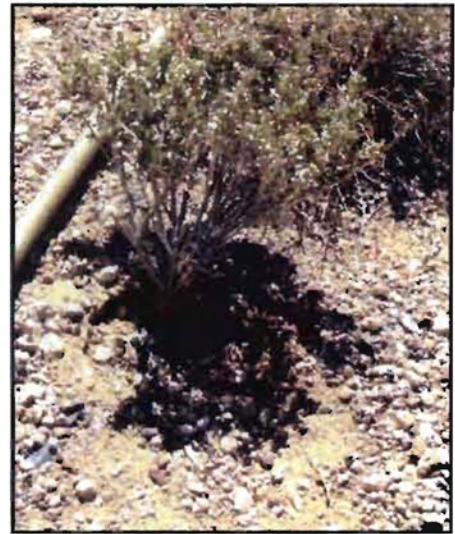
the roots, in search of moist and more palatable portions of the plant (Figure 5). In most cases plants recover from above ground browsing; however, the attack on the roots of the plant usually results in plant mortality. Over the past few years the density of shadscale has decreased as plants have matured, and resources have become more limiting. The intensive browsing observed this year along with burrowing into the roots coupled with the effects of severe drought conditions may result in even lower plant densities in future years. At the same time the plants that are present are native to the area and have adapted to dry conditions. When favorable growing conditions return, these plants will flower and set seed, like they have in previous years, thus improving the potential of young plants establishing and filling any voids that may have been created from plant mortality during this drought period.

Figure 5. Small mammal burrowing into roots of shadscale.

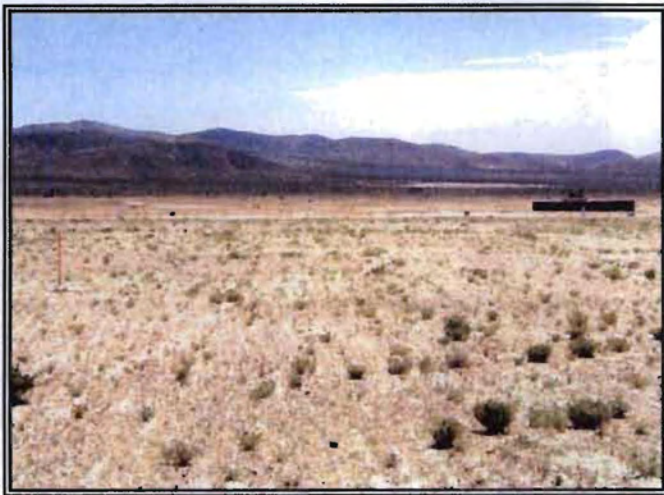
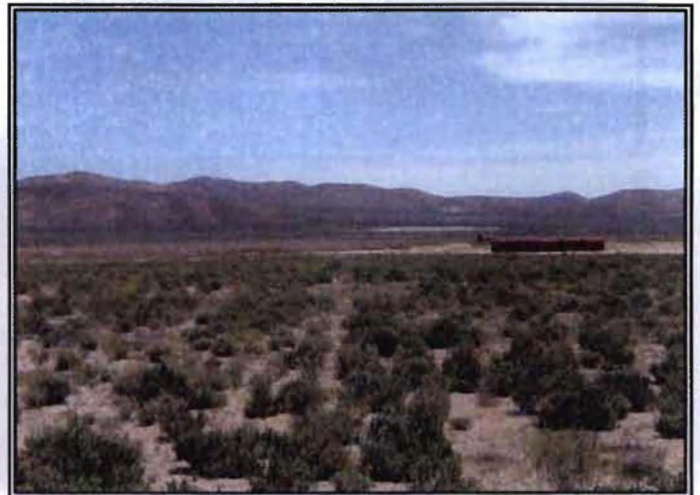
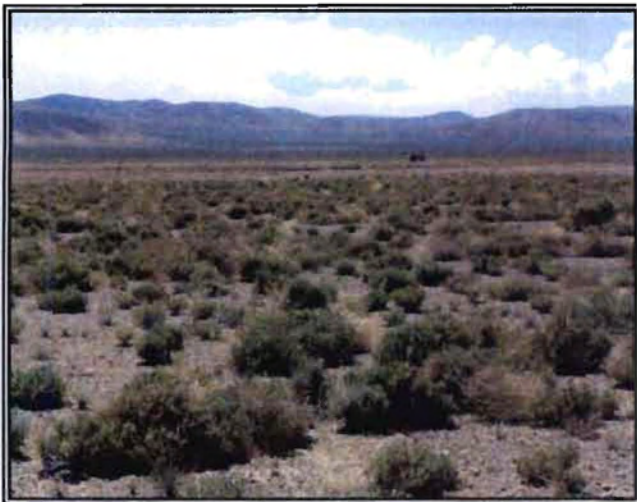
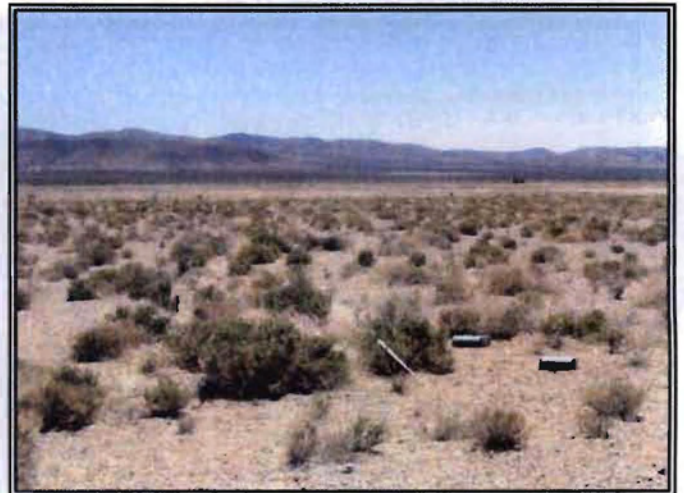
The perennial plants found on the closure cover at U3-ax/bl appear to be well established and continue to provide a viable vegetative cover (Figures 6a-6d; 7a-7d). Some species are less tolerant of dry conditions, but with increased precipitation these species seem to recover. There appears to be added stress on the plants from the robust populations of small mammals and lagomorphs the last couple years. There is no indication that remedial revegetation is necessary at this time, but vegetation monitoring in future years should focus on the effects of the increased number of small mammals and lagomorphs recently, specifically on the density and vigor of the perennial plants present on the closure cover. Also it is important to monitor the presence of annual weedy species, such as halogeton, cheatgrass, and Russian thistle. The peripheral area between the cover cap and the fence has become a source of seed for these weedy species. Without a cover of perennial native plants these areas are prone to invasion by annual weedy species, which then can spread onto adjacent areas. Currently these species are in check on the closure cover; however, if they increase in density on the closure cover, some remedial action may be necessary to protect the composition and stability of the vegetative cover on the closure cover. Any significant ground disturbances on the closure cover where the vegetation has been removed or heavily disturbed should be vegetated. Weedy species, such as halogeton or Russian thistle, are poor competitors and it is important to as quickly as possible, establish a vegetative cover comprised of native perennial species. This will minimize the possibility of these areas being dominated by noxious weeds and serving as a source of seed for these species.

Figure 6a. CAU 110, U3-ax/bl closure cover: June 2002, looking southeast from center of cover.

Figure 6b. CAU 110, U3-ax/bl closure cover: June 2005, looking southeast from center of cover.

Figure 6c. CAU 110, U3-ax/bl closure cover: May 2006, looking southeast from center of cover.

Figure 6d. CAU 110, U3-ax/bl closure cover: May 2007, looking southeast from center of cover.

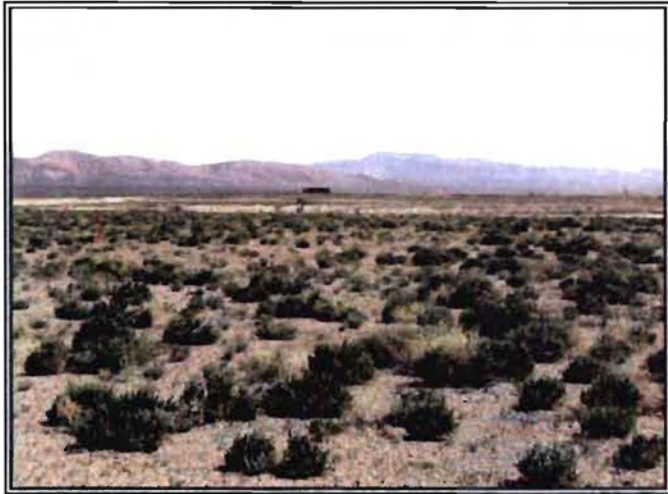
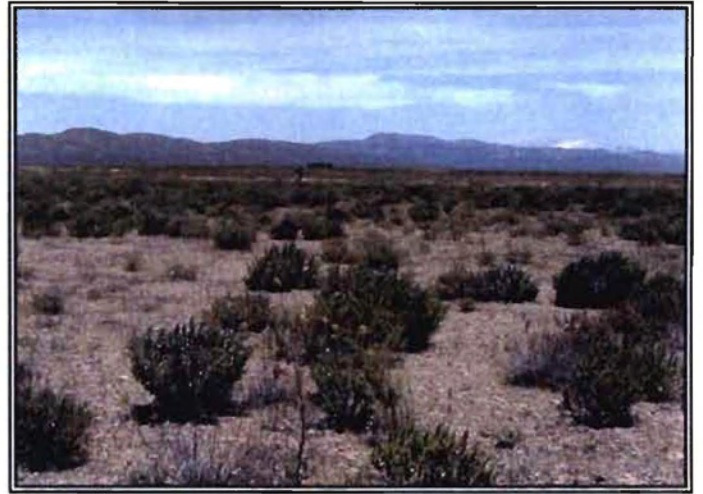
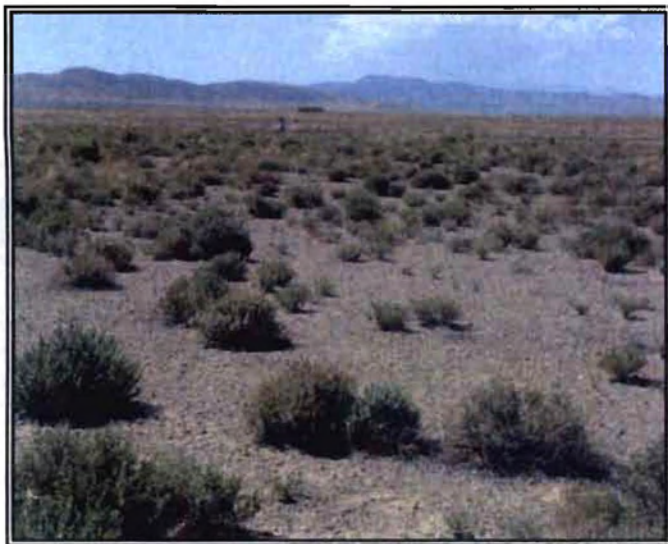
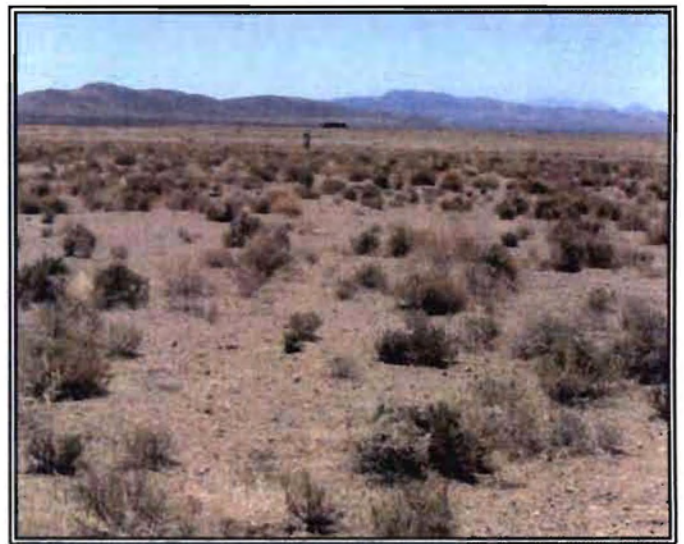
Figure 7a. CAU 110, U3-ax/bl closure cover: May 2004, looking southeast from center of cover

Figure 7b. CAU 110, U3-ax/bl closure cover: June 2005, looking southeast from center of cover.

Figure 7c. CAU 110, U3-ax/bl closure cover: May 2006, looking southeast from center of cover.

Figure 7d. CAU 110, U3-ax/bl closure cover: May 2007, looking southeast from center of cover.
